## Recommendations for Inspecting DOT- SP12516 FRP Cargo Tank Trailers

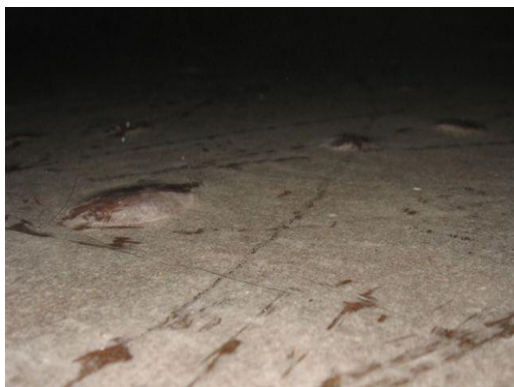
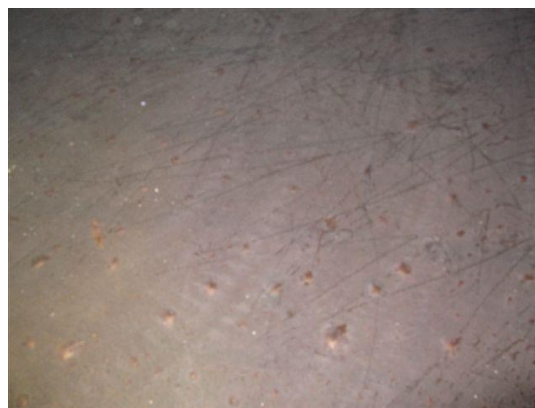
#### Blisters:

Typical small blisters common in small molecule acid service such as hydrochloric acid. This is a normal part of aging in these type services. Eventually, the blistering will progress to a state where the acid will “leak” out of the blisters. Tankers that have conductivity will likely pass a spark test for several years after blisters are noticed. Even in advanced cases, tankers may pass annual spark test inspections without migration into the conductive zone depending on the thickness of the liner.

Once acid has migrated into the conductive zone carbon fiber veil used as a conductive material offers a high degree of protection to the structural fibers as an additional level of safety. However, any tanker that fails a spark test should be removed from service and relined. Conductive carbon veil should NOT be relied on for product containment in this situation.

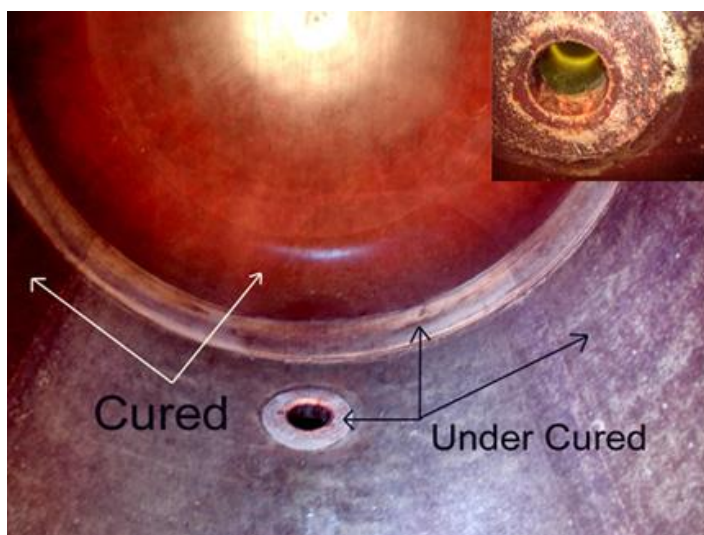
### **Under Cured Lining:**

Severe degradation of the veil layers exposing the glass mat fibers below. These fibers will be attacked by exposure to sodium hypochlorite, hcl, and other products that are known to be incompatible with glass fibers. While the effects are in need of repair, they don't pose an immediate threat of failure. Tankers that are capable of being spark tested and pass this inspection would not be required to be removed from service since the fiber is not interfering with normal operations. Relining or repair of localized area as shown in the nozzle should be considered to be conservative.

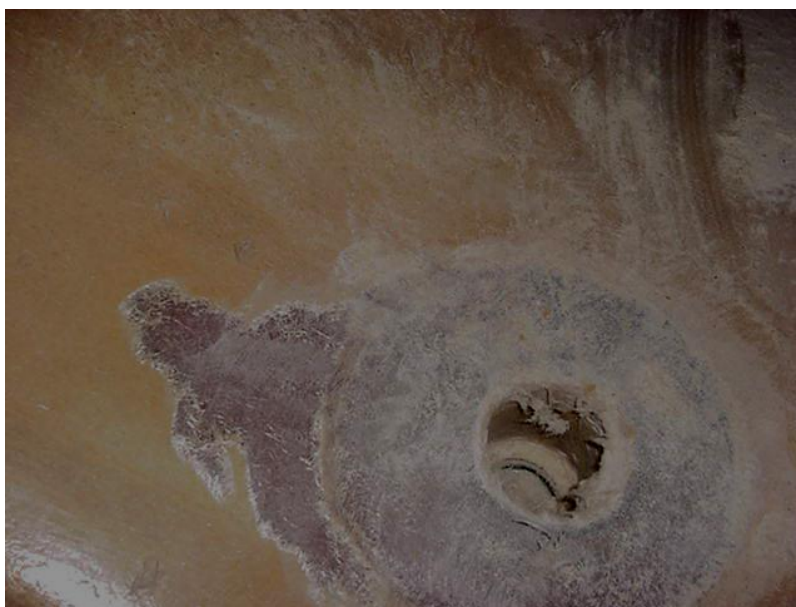
Significant attack of the surface veil layers extending to the underlying glass fibers. Very predominate fiber exposure. This will cause a wicking effect within the laminate and provide a pathway to the structural fibers that could result in shell failure if left unchecked. Commonly referred to as "Fiber Bloom". This is an advanced stage of attack and because the nozzle cap is completely deteriorated the tanker should be removed from service and relined. Caution should be noted in these cases that chemical products have not contaminated the critical structural fibers. If this is the case, the tanker should NOT be relined and instead returned to the manufacture for inspection.

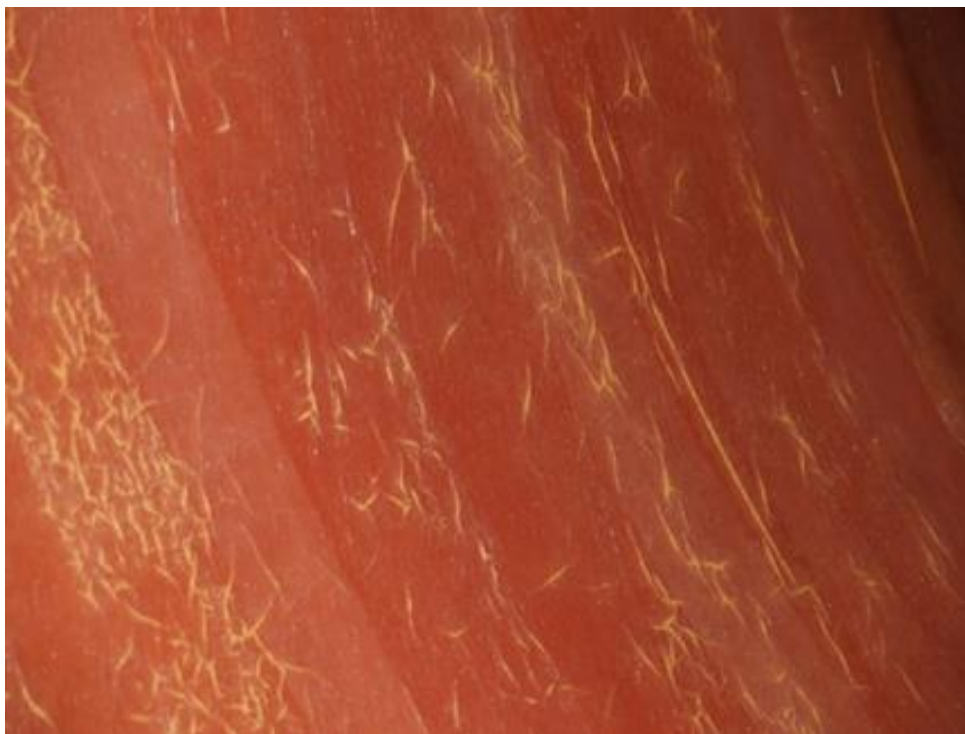
**Stress Corrosion Cracking or Micro Cracking:**

Typical sign of stress corrosion cracking in the surface layers. This is caused by highly oxidizing chlorine environments specifically. This is produced by the decomposition of sodium hypochlorite solutions in the vapor phase. Characterized by hundreds of small cracks that are more prevalent in the resin rich areas. In time they can allow product to migrate into the glass mat fibers and will cause what is known a fiber bloom. The process is somewhat slow reaching these underlying glass layers but progress should be monitored. Tankers that have conductivity capability are able to monitor the extent of migration to the conductive layer and it's possible the tanker could operate for many years in this condition without interfering with the normal operation. This is a good example why conductivity is an important tool for accessing liner condition and management of repairs.

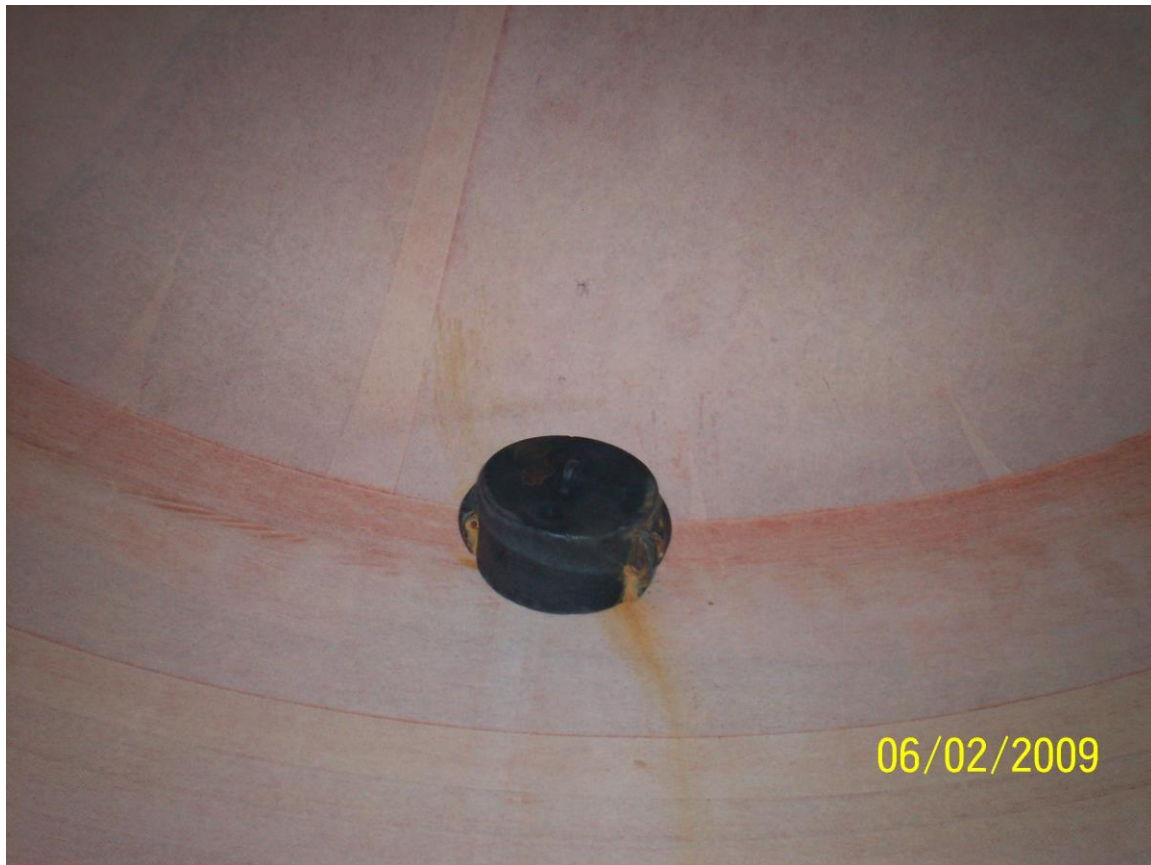
**Surface Dryness:**

Some products will cause the resin rich layer to deteriorate exposing the surfacing veils to direct product contact. This is predominately seen in alkaline or caustic applications especially where hot products are involved.

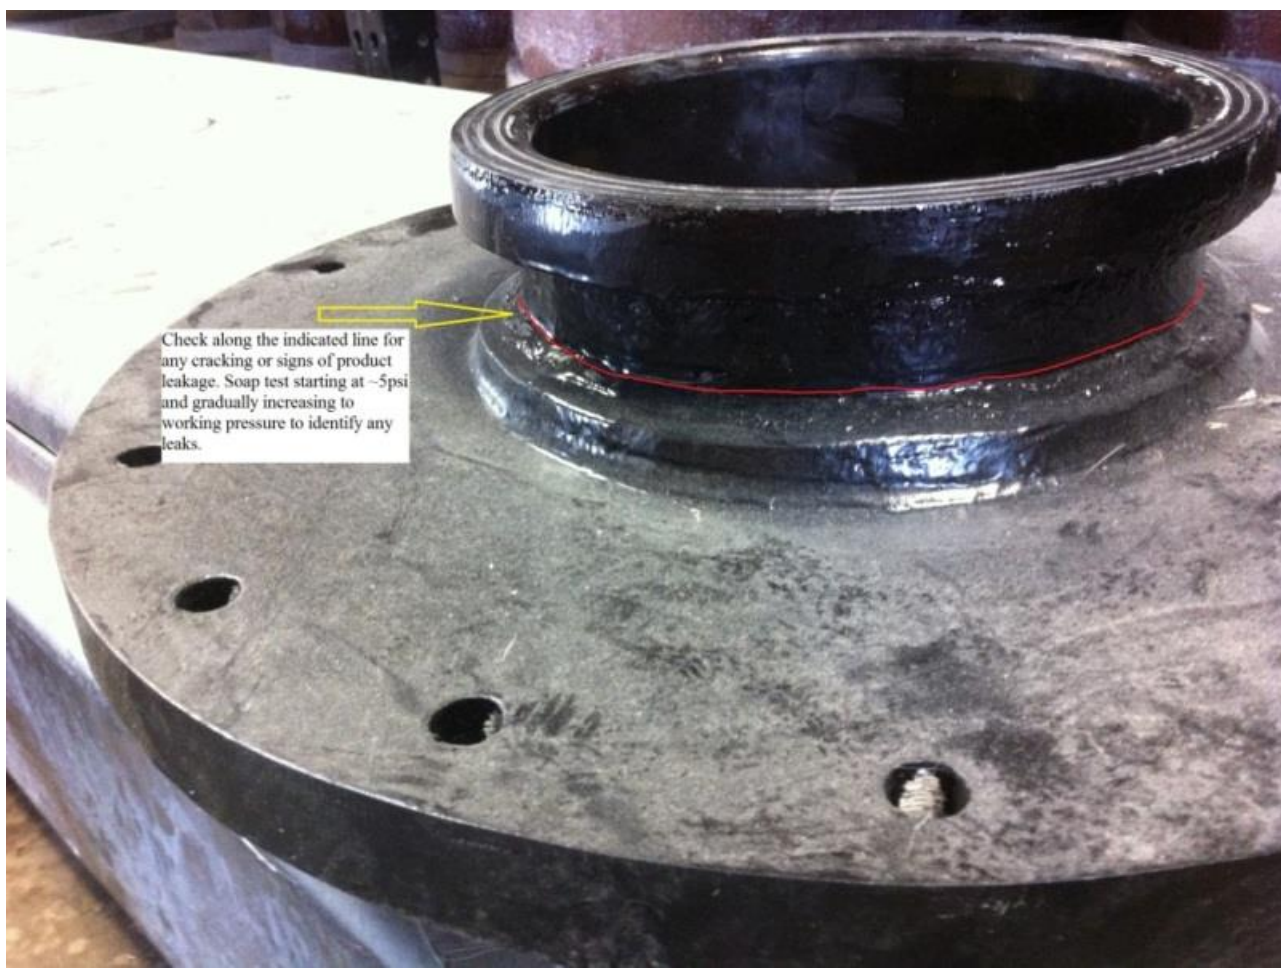
**Manway Inspection:**

During the annual inspection, please make sure to include the manway lid. Inspect for any visible signs of cracking.

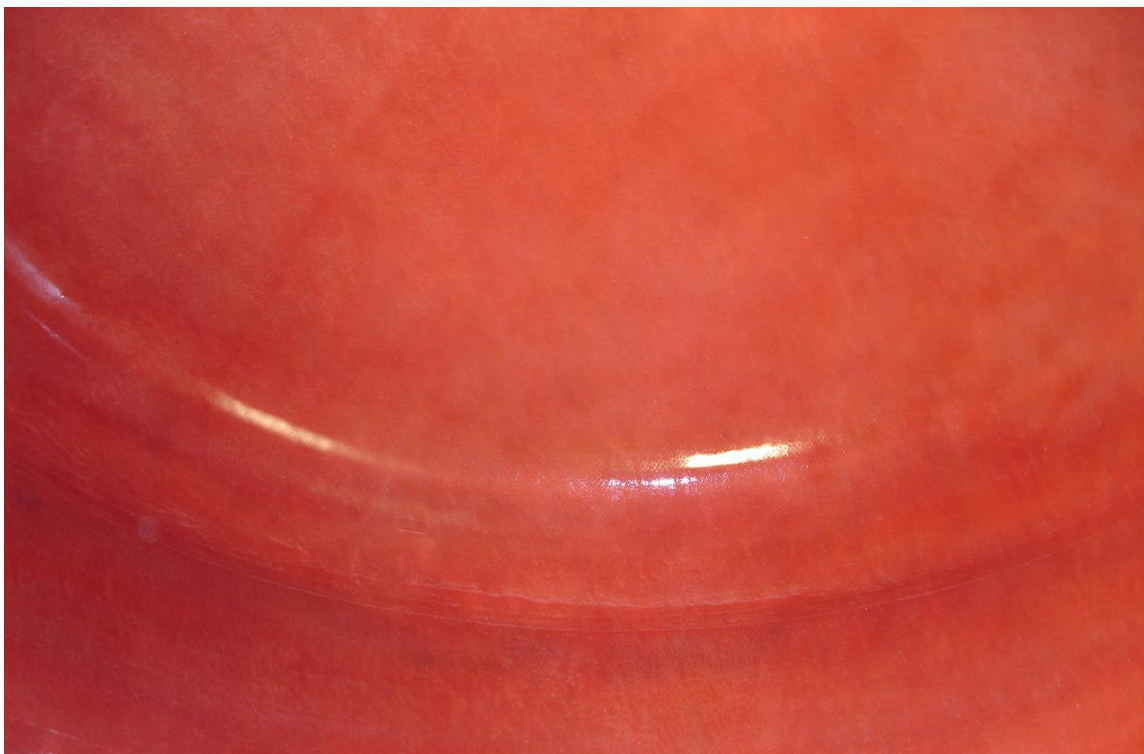
**Normal Lining, No Defects:**

Condition of fully cured lining after 2 years of hypochlorite service where no stress corrosion cracking has occurred.
